Tests performed on RB.A12

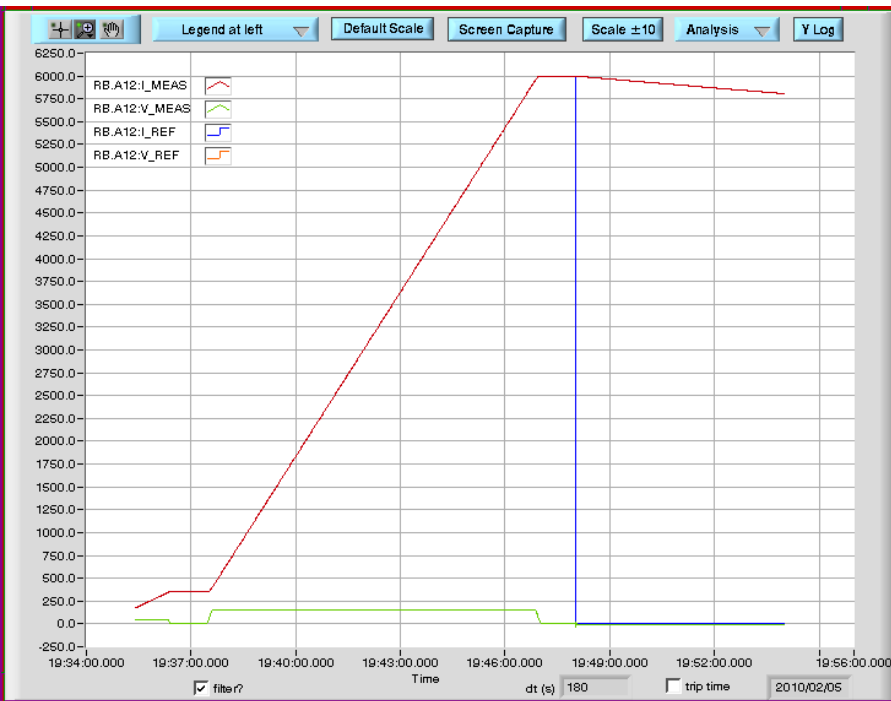
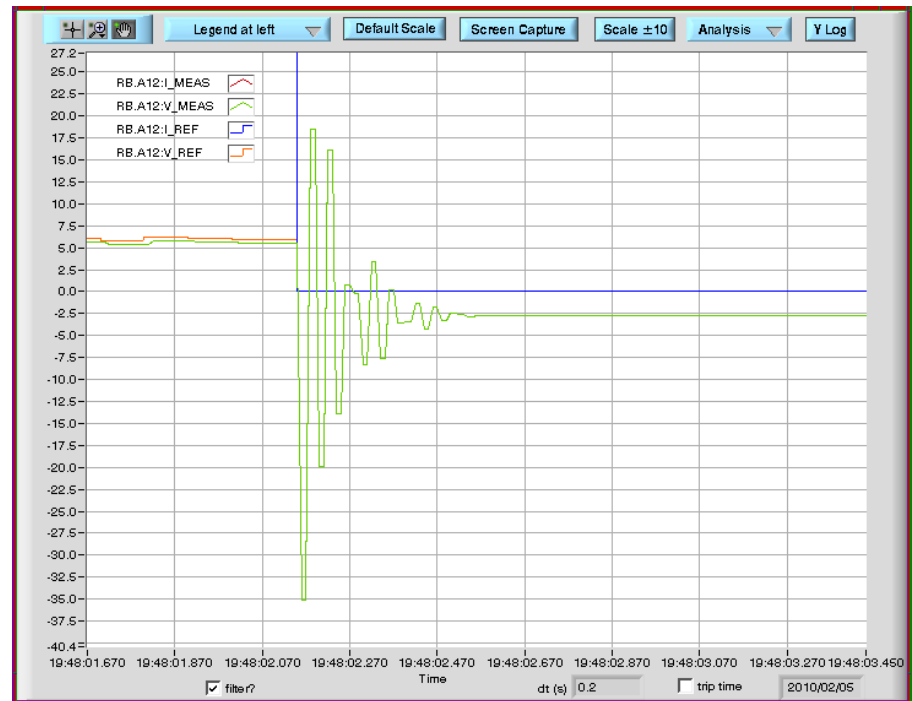
Simultaneous FPA and PC fault

- PIC global protection mechanism, trip of other circuits during the ramp-up or ramp-down
- EE opens few milliseconds after the converter stops.
- Immediate amplification of the converter ringing in all sensitive magnets

- Proposal :
 - Delay the PC off by PIC by 20 ms
NB: This is affecting all 13 kA circuits : Type A circuits (RB, RQD, RQF, triplet)
 - Global bus bar detector for sector 12 threshold increased (functionality taken over by nQPS BS system) [From 1V to a few V]
- PIC tests performed yesterday to check the 20 ms delay (OK) without current
- Tests performed with current (1/2):
 - RB: ramp to 500A, slow abort during constant current (produces a controlled ramp down) - nothing trips
 - Ramping up and provoking a fault around 500 A: no trip.
Then switch opening around 400 A : no trip
 - Ramping down (-10 A/s), and provoking a fault around 500 A: no trip.
Then switch opening around 400 A : no trip
 - Ramping up and FPA from PIC around 1 kA: heaters fired in two magnets, A20L2 and B17L2

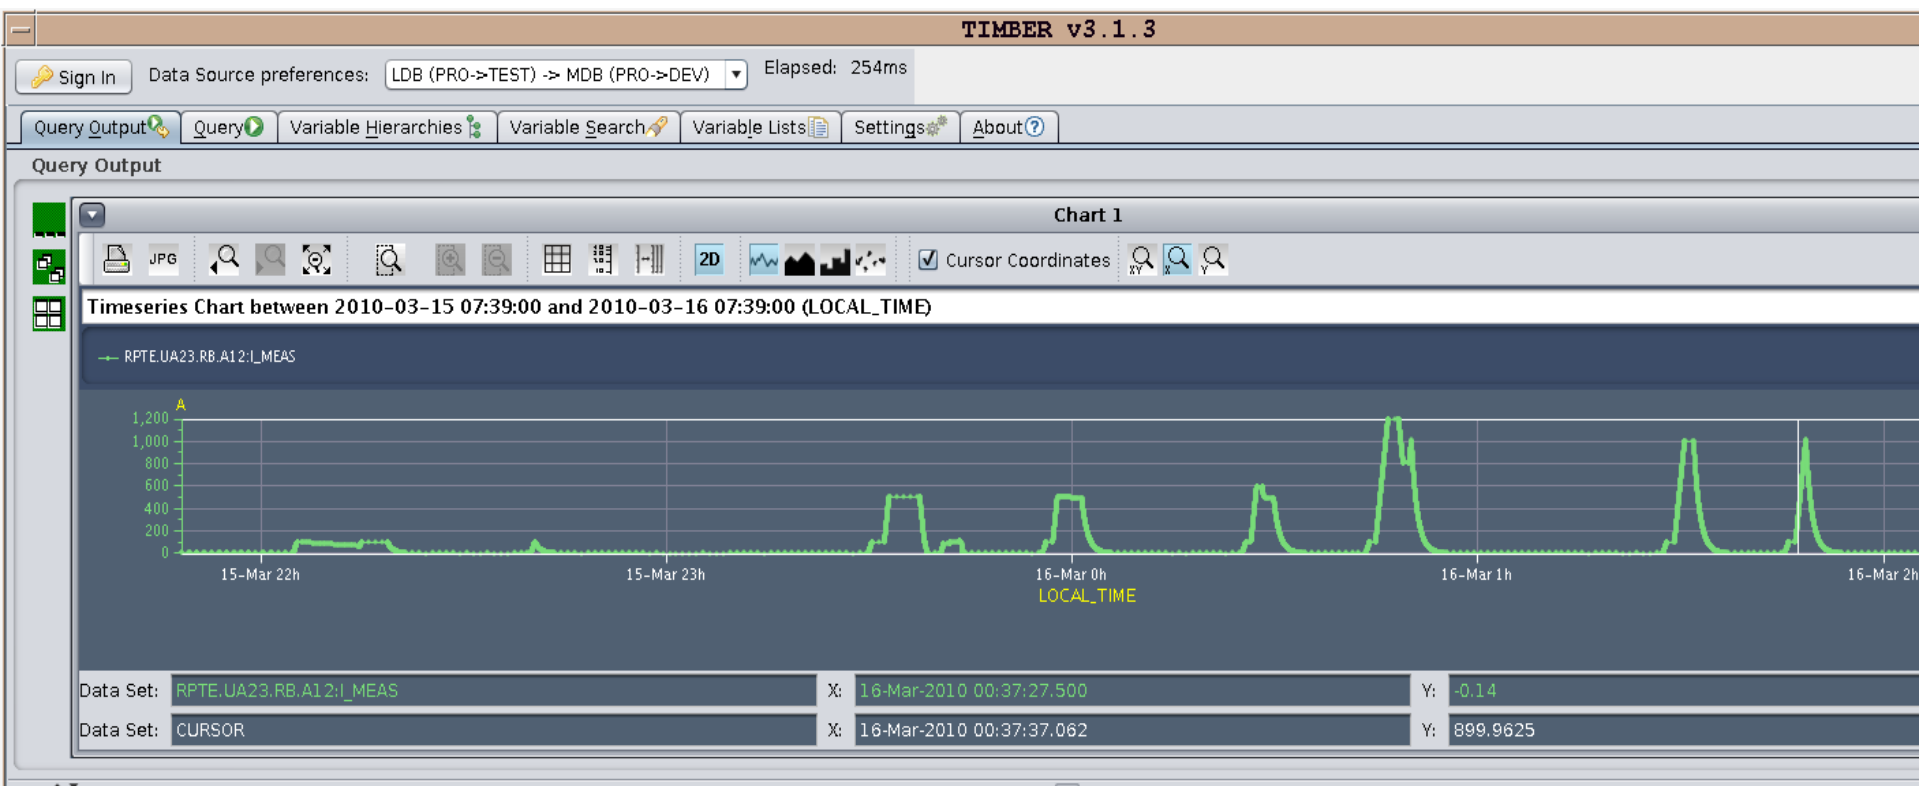
- Tests performed with current (2/2)
 - Ramping up and PC fault generated around 1 kA, after few hundred ms, the switch opened and no heater was fired.
No global busbar postmortem that would point at an HTS trigger, and splice-monitoring shows all nQPS BB signals well behaved.
