Tests performed since yesterday

Tests performed on RB.A12

17th of March 2010

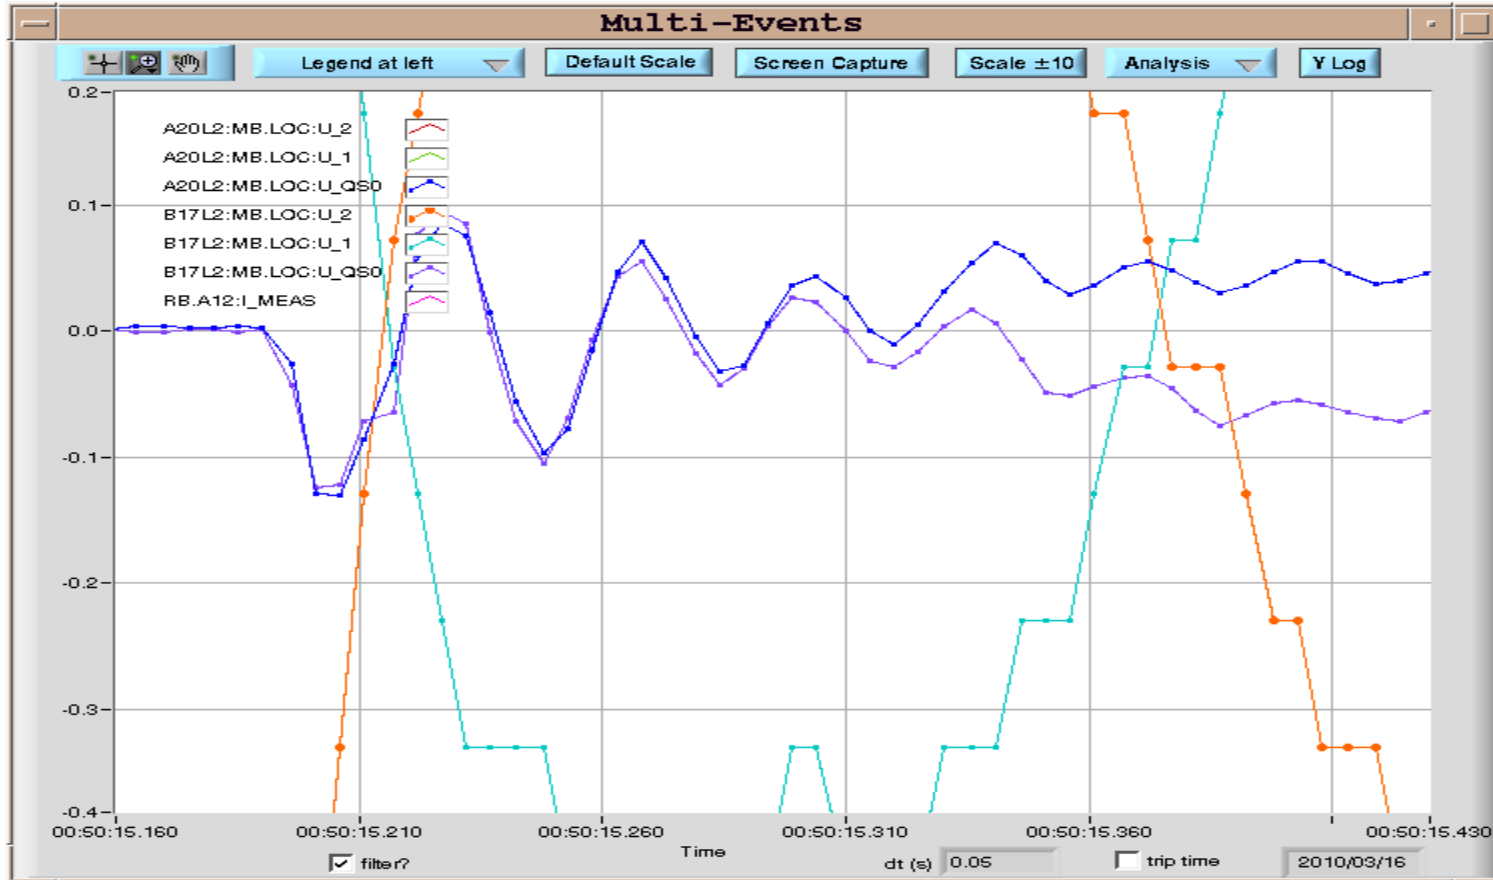
Increase threshold on both magnets where quench heaters were fired
A20L2 and B17L2. (Global BB detector for mains deactivated)

➤ FPA from PIC ~ 1 kA during ramp 10 A/s: Repeated : NO TRIP 😊

➤ Decision 1:

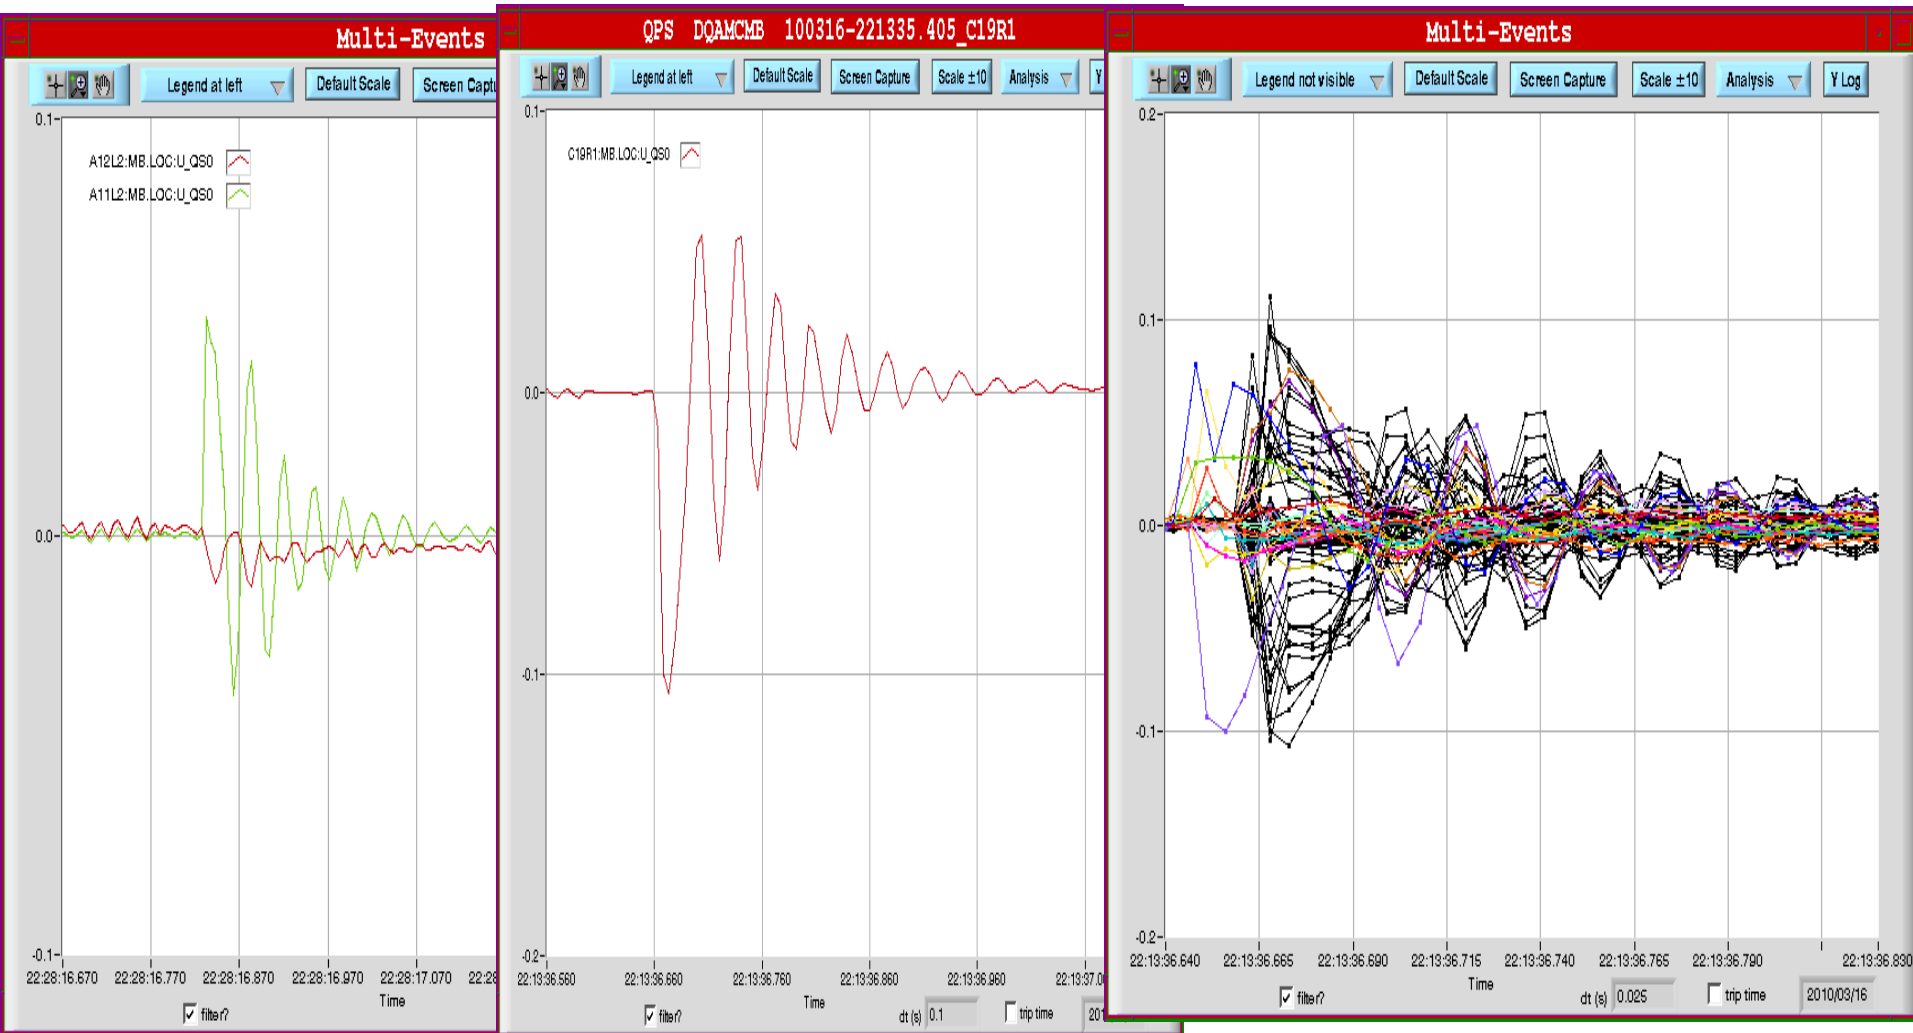
FPA @ 1 kA to have acquisition of U_QSO

Magnets closed to threshold (#19) :

R1:C29,A29,B28,B27,A27,C24,A22,C21,C19,

L2:B31,C30,A30,C28,B23,A22,C19,A18,B15,B11

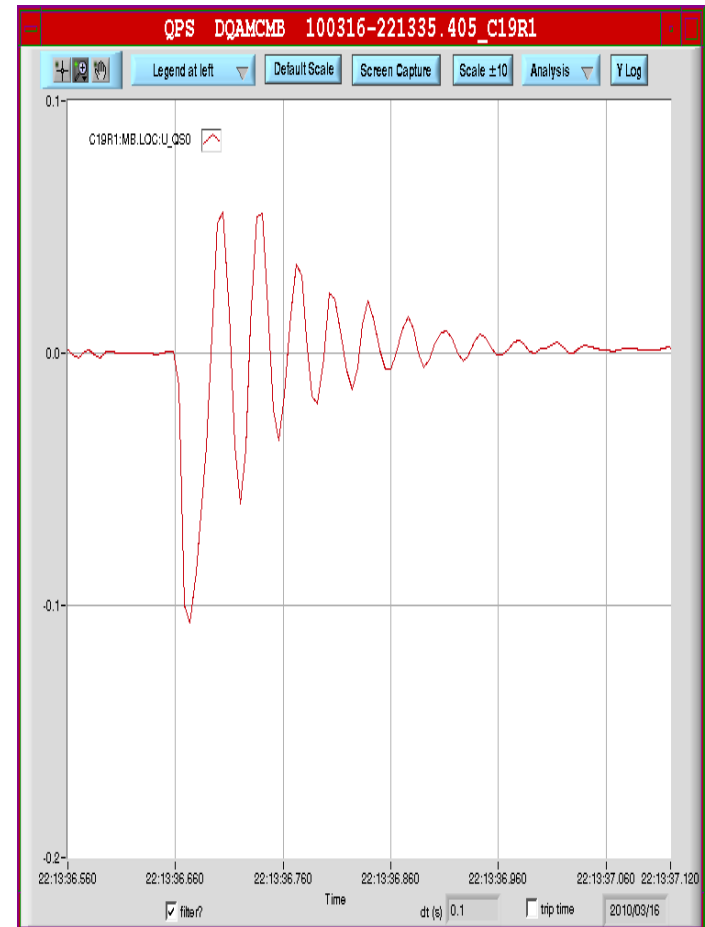
FPA @ 2 kA from flat top. C19R1 triggered the QH

V Meas ringing amplitude is 40 V

Asymmetry between apertures seems to play a secondary role

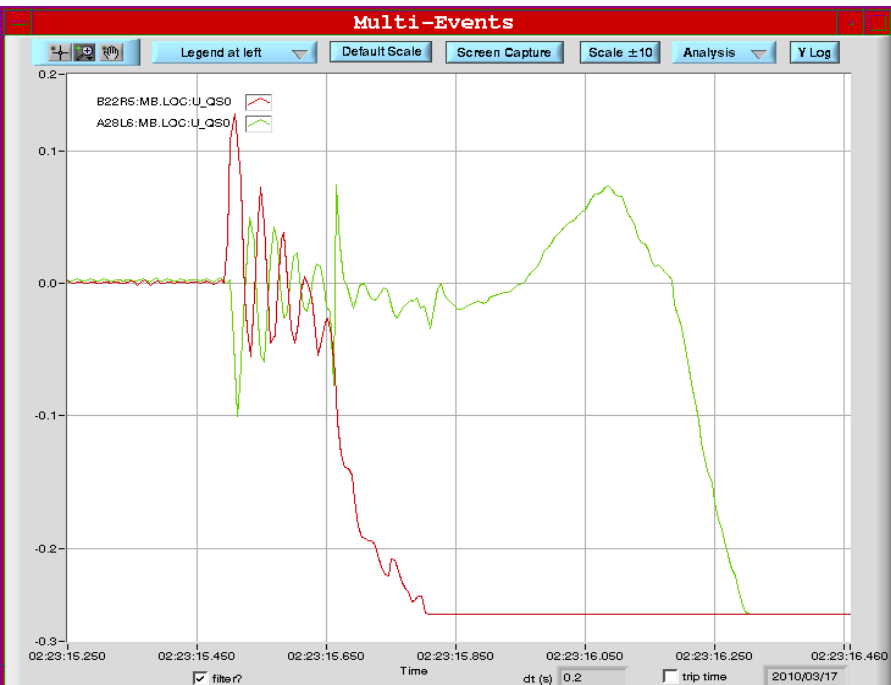
- FPA via PIC during ramp @ about 2kA : 30 magnet quenched !!

Most (All?) triggers come from old QPS
But close to 800 mV of nQPS also
Ringing > 100 V (Already last year)

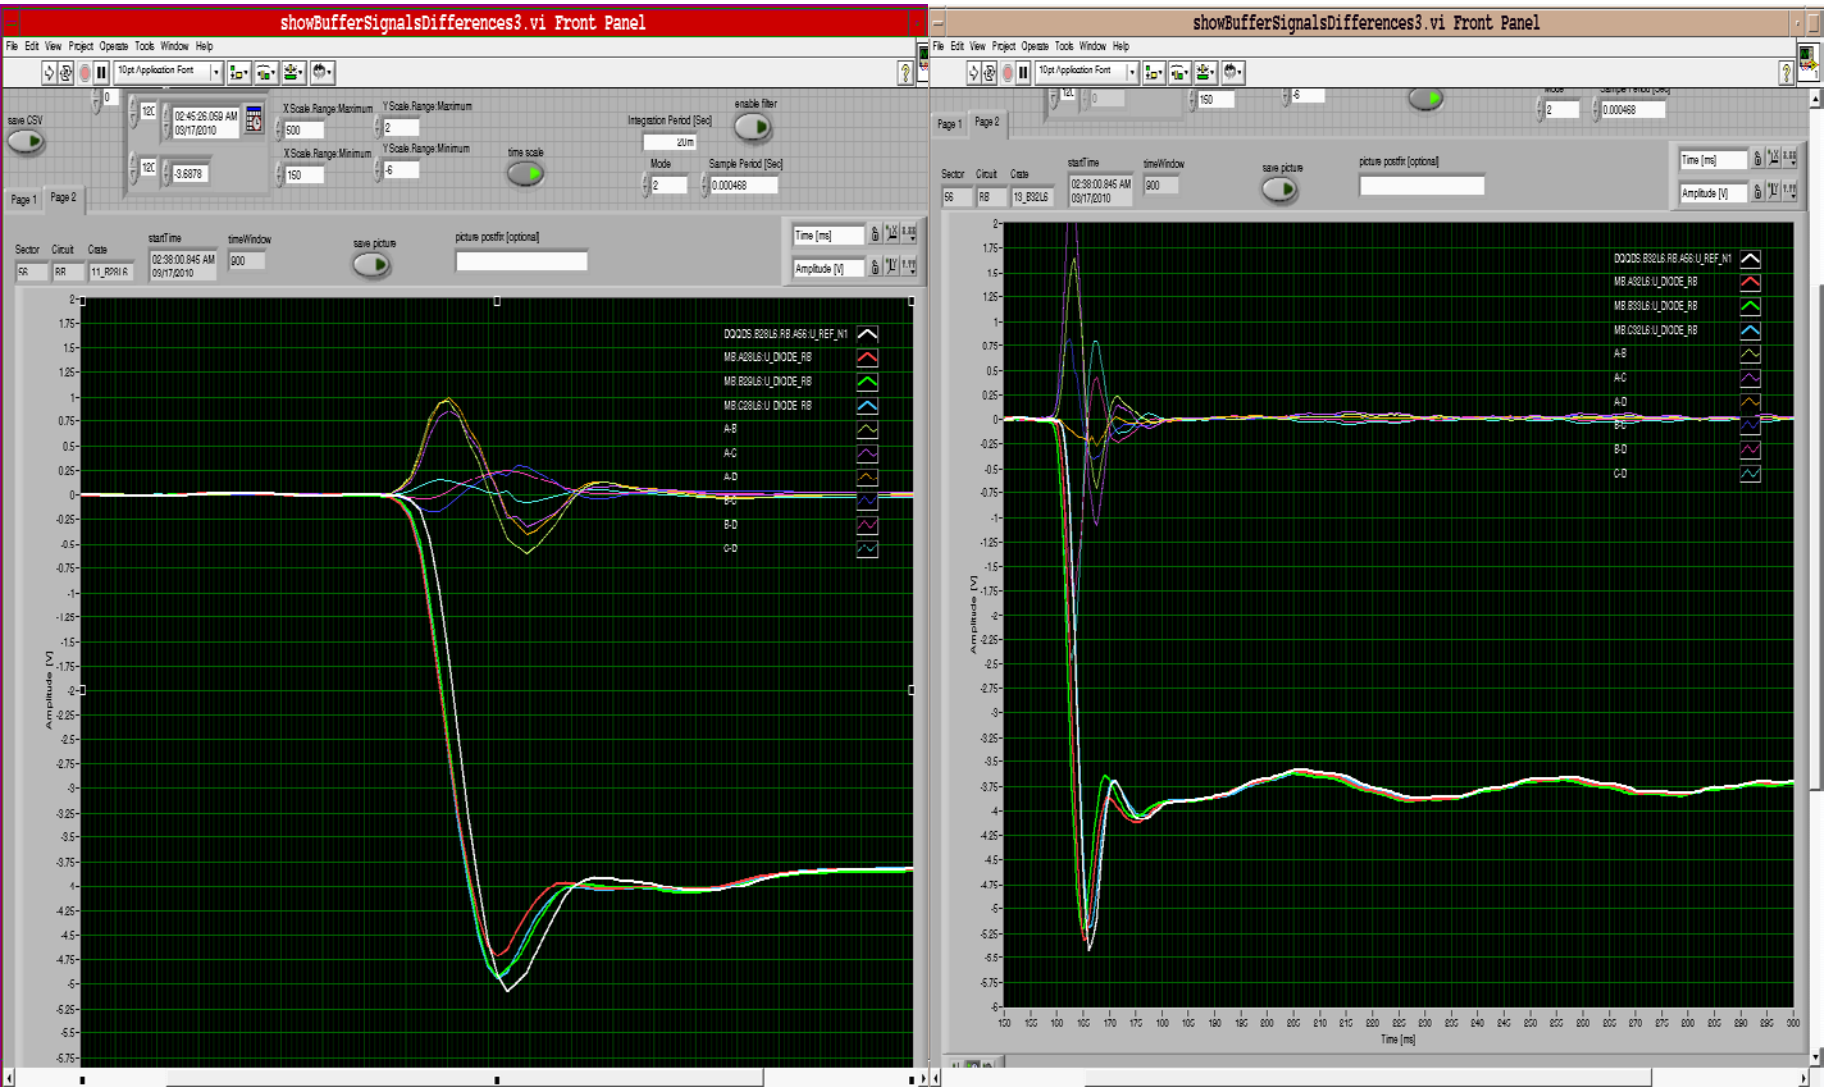
30 quenches on RB.A56: To be analysed

- FPA via PIC during ramp @ about 2kA :
30 magnet quenched !! Some perhaps from nQPS (Sunglasses active)
