“LHC Operation: MP3 List of Issues”

Status at 22 March 2010

MP3 - Team

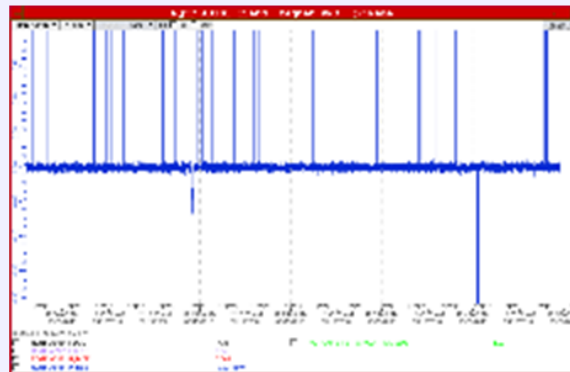
20100319005425.png

Ex. (on the LEFT) of a noisy QPS board (that end frequently with a trip of the circuit).

Monitoring via LHC Circuit Supervision the U_res of RQTF.A81B1; signal shows a lot of spikes. By comparison I plot it here below with the RQTF.A78B1

On the RIGHT a good signal for a similar circuit in another Sector. (NOTE: the noisy board was then changed)

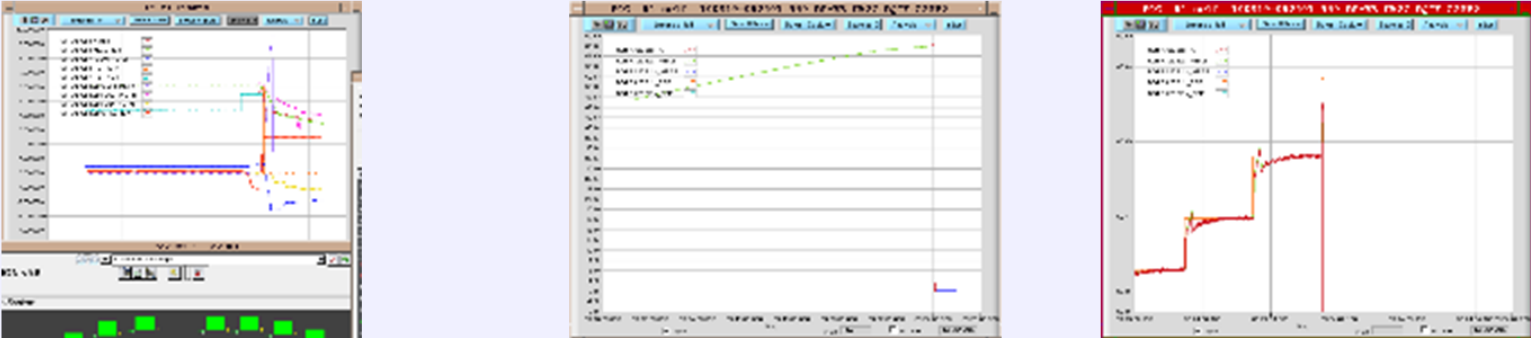
FGC 51_self 100319-052401.940_RPMBB-UA27.RQTF.A23B2

Ex. Of Beam Feedback correction "too hard to be digested" by PC and QPS.

LHC MPP LOCATION > Sector 2-3
CIRCUIT : RQTF.A23B2
COMMENT : During plateau at 3.5TeV B2 was dumped. RQTF.A23B2 was the first trigger (seen on PIC), the trigger was given by QPS.
It seems evident that the U_RES increased while trimming of the beam. Increase of the requested rate gave U_RES signal over threshold for three points.
Increasing of U_RES can be observed also during previous trimming, approaching the threshold as well but not reaching it.
Beam 1 was dumped some 11 sec. after.

(Note Feedback was disactivated in yesterday runs at 3.5 TeV in order to avoid eventual trips during beam measurements)
