# MP3 report - week 17

## 19/4/2010 - 25/04/2010

MP3/QPS team in CCC

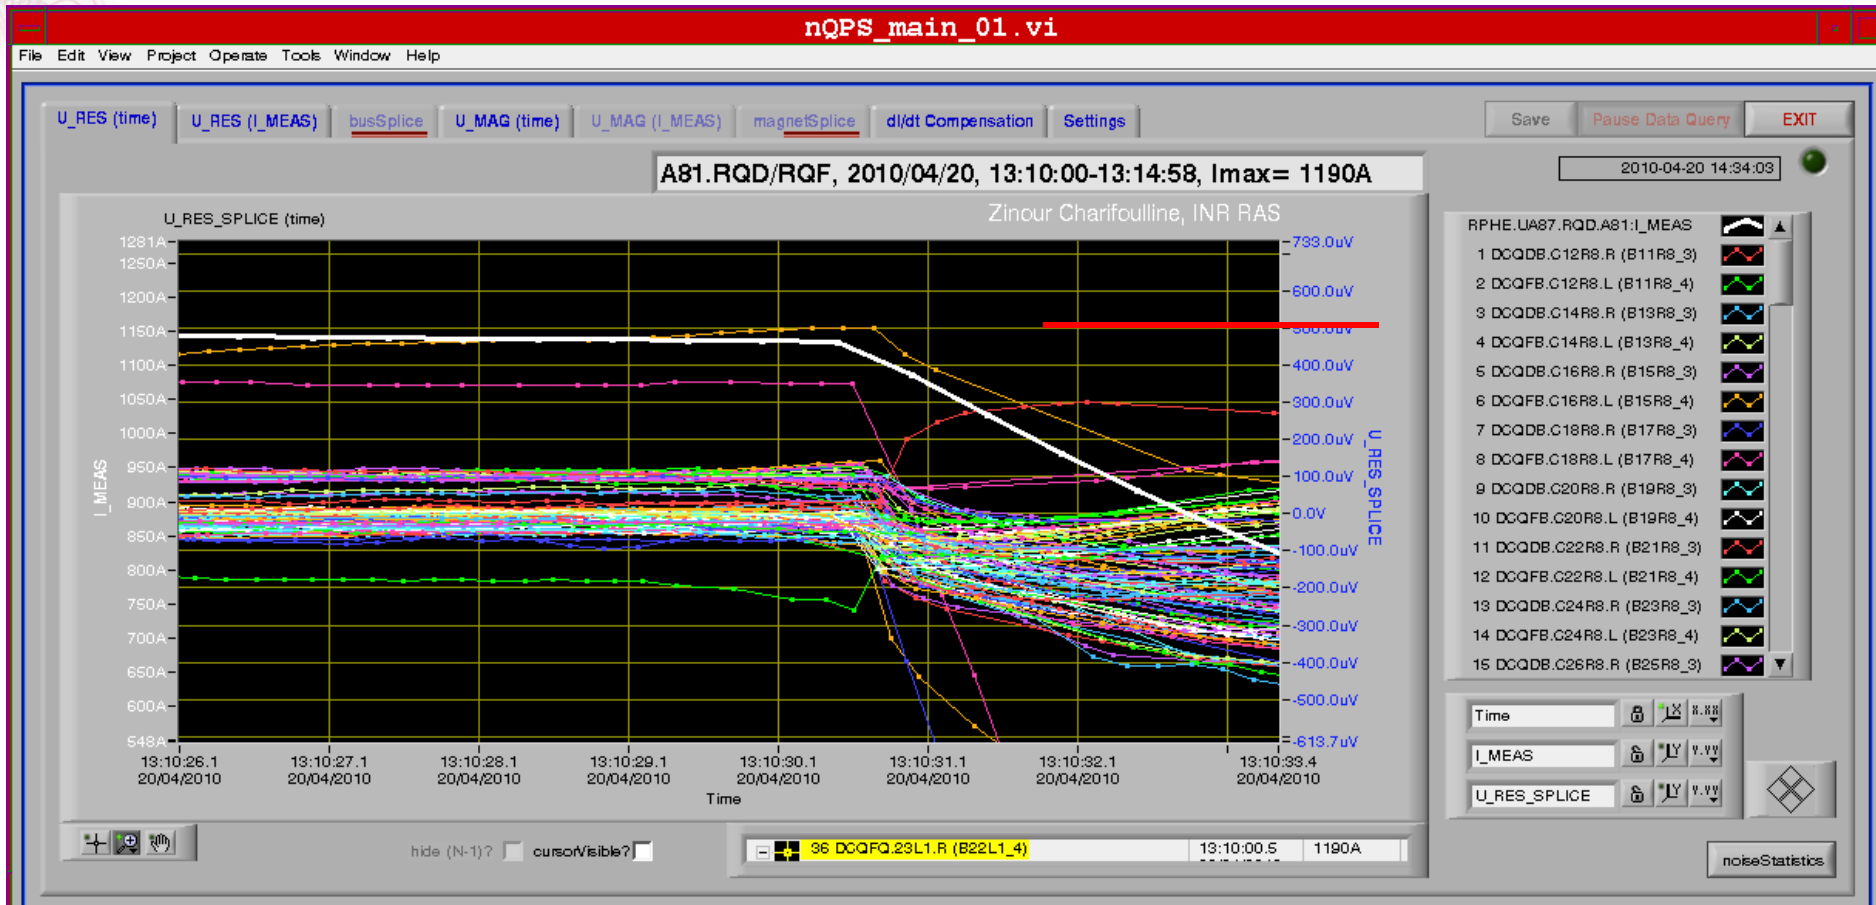
# RQD/F.A81 on Tuesday and Friday

- Trip induced by nQPS at 6kA on Tuesday, at 1.4kA on Friday
- Noisy board in B22L1 : New Threshold of 0.6mV

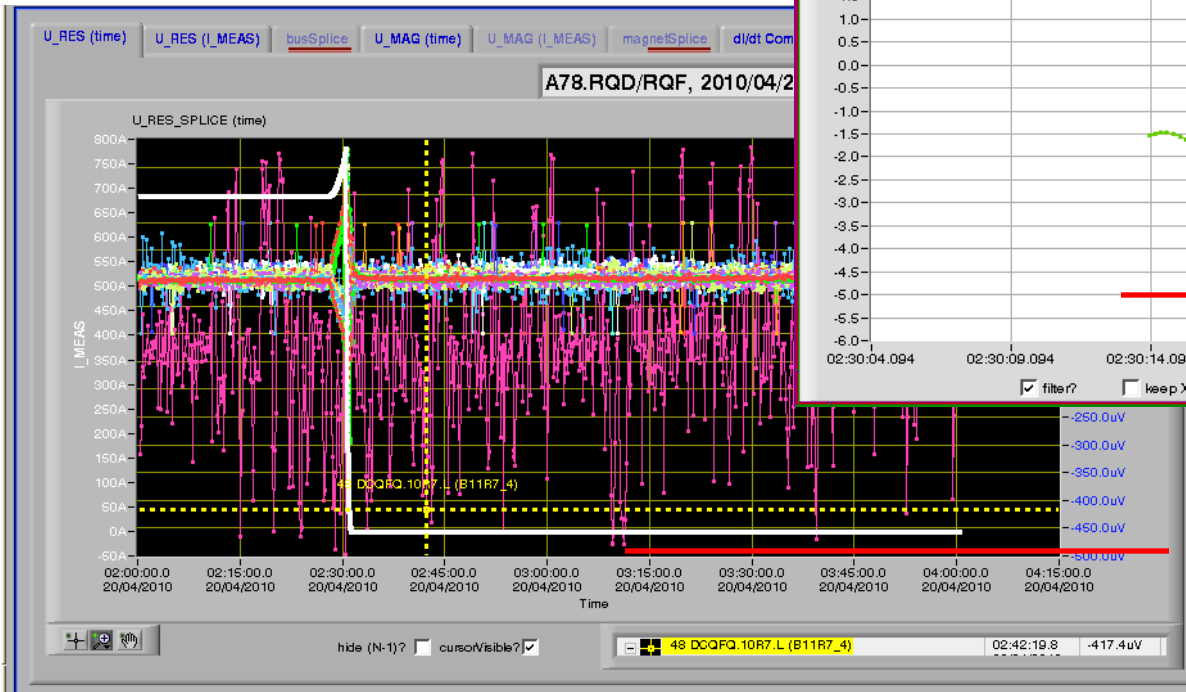
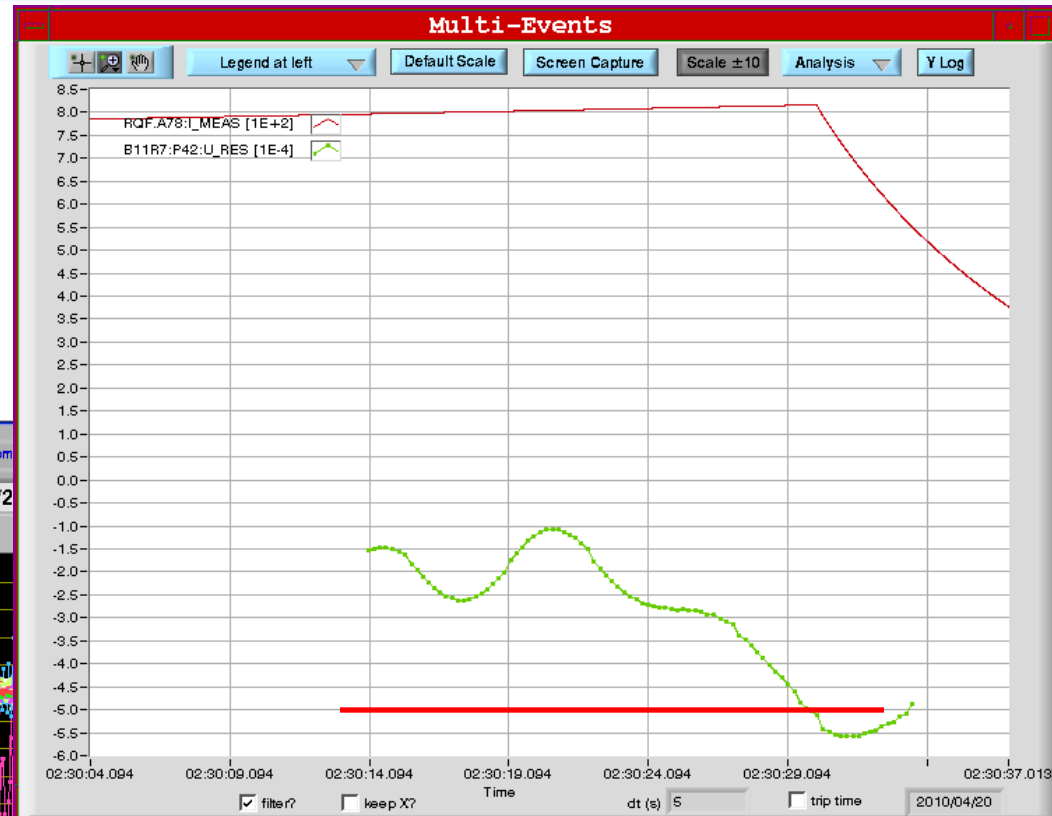
# RQF.A78 on Tuesday

- Trip induced by nQPS at 781A
- Noisy board in B11R7 :  
new Threshold of 0.6mV

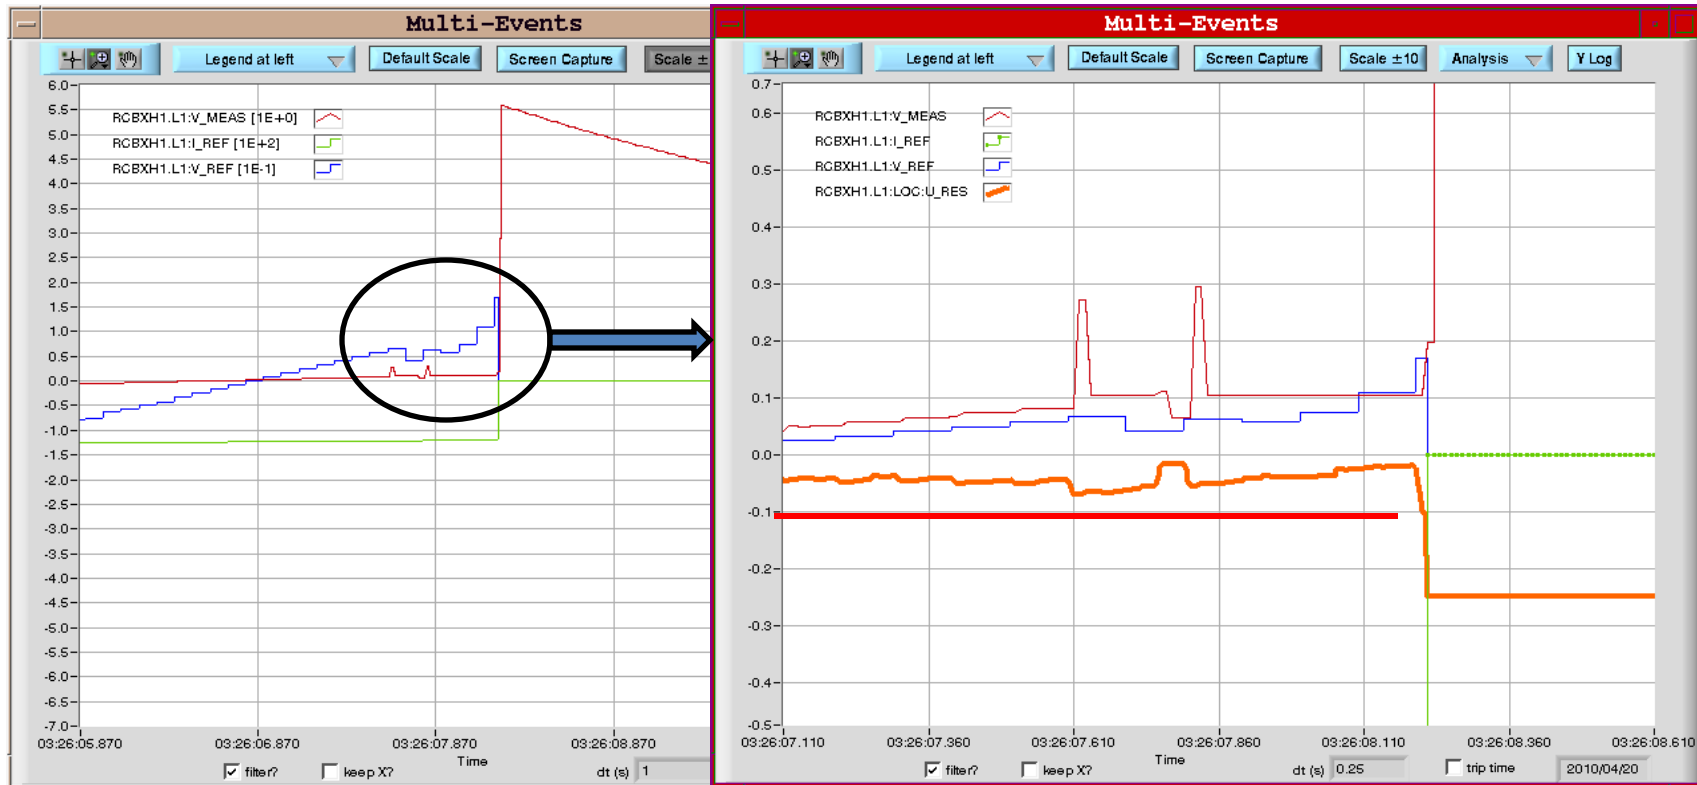
# RCBXH1.L1

- Tripped during ramp down of a precycle at 120A.
- 0 Voltage crossing : Perturbation created by PC when the voltage polarity is changing can be not compensated by QPS

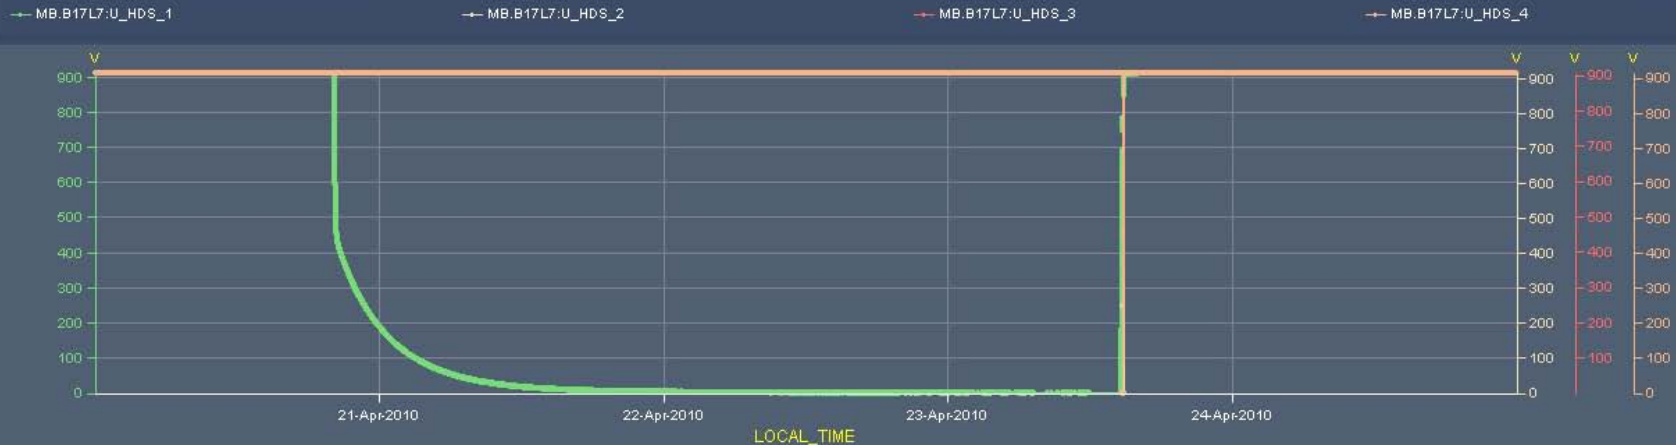
# Quench heater power supply in RB.A67

- 1 QH power supply discharged (MB.B17L7) from Tuesday  
Can be tolerated temporarily @ 3.5 TeV
- Fixed the 23/04 during intervention for UPS in RE73.

Timeseries Chart between 2010-04-20 00:00:00 and 2010-04-25 00:00:00 (LOCAL\_TIME)

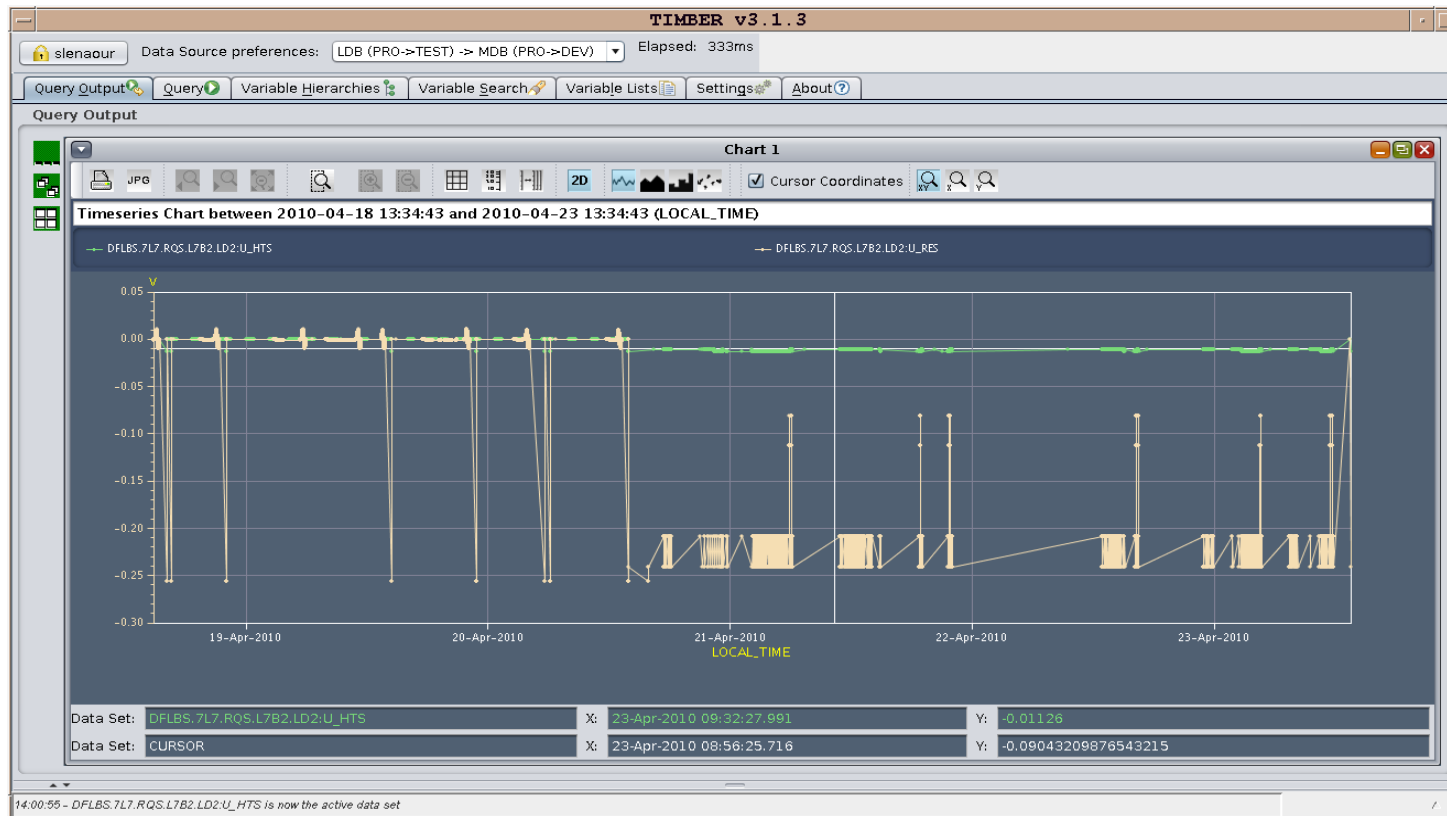
# RQS.L7B2 on Friday and Sunday

QPS not OK on 600A global detector. 1 board on current lead blocked since 3days. Not a major issue because the redundant board was still working.

*QPS\_OK of 600A systems are not checked during the software interlock*

Similar problem showed up on Sunday . Temporally fixed

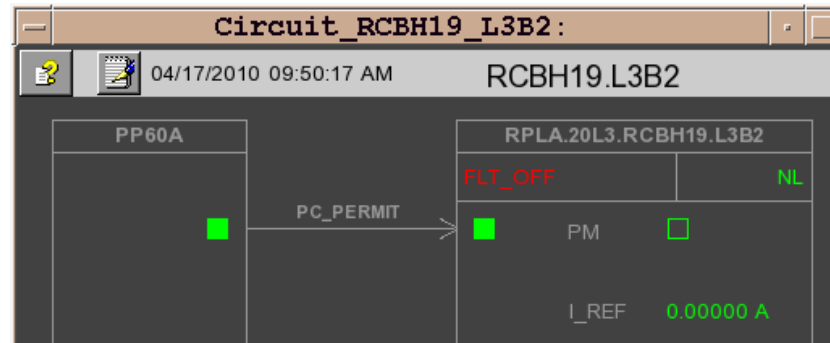
- RCBH19.L3B2 & RCBV19.L3B1 : Seems to have a PC issue  
EPC informed
