MP3 report - week 17 26/04/2010 - 02/05/2010 17 interventions

MP3/QPS team in CCC

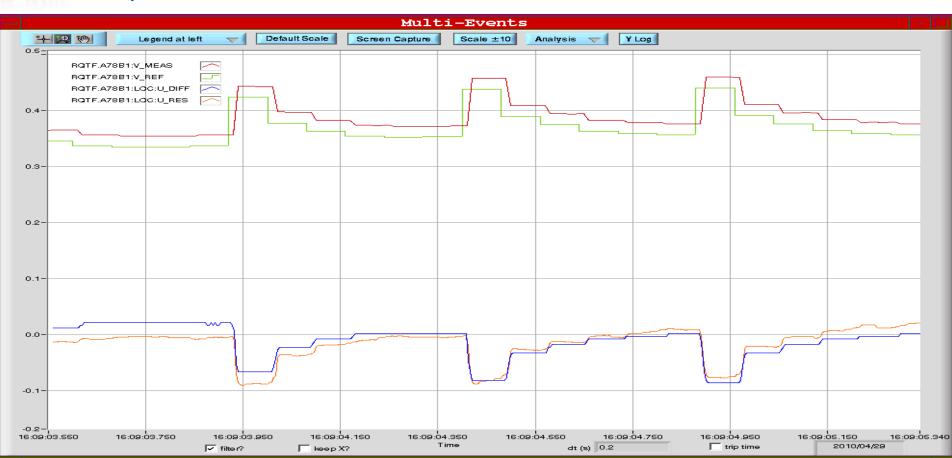
- During technical stop, the time discrimination was increased from 20ms to 200ms
- Test performed in 56 on Wed 28/04 and successful

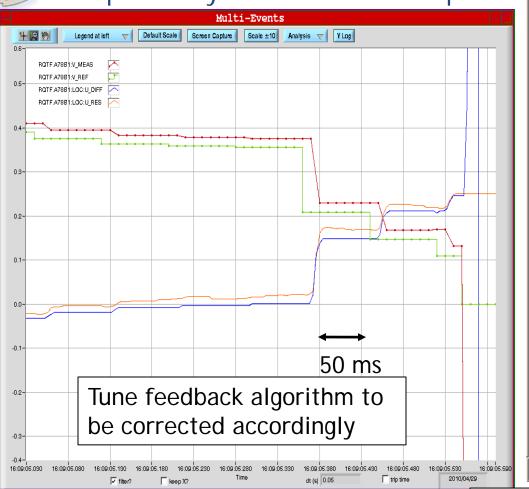
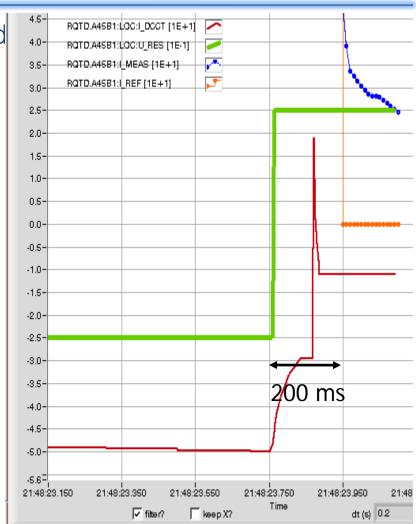
Trips but system reacted as expected

28/04: Trip of RQTD.A45B1 during test due to wrong polarity (solved in tunnel by MPE piquet) but the 190 ms delay is well seen

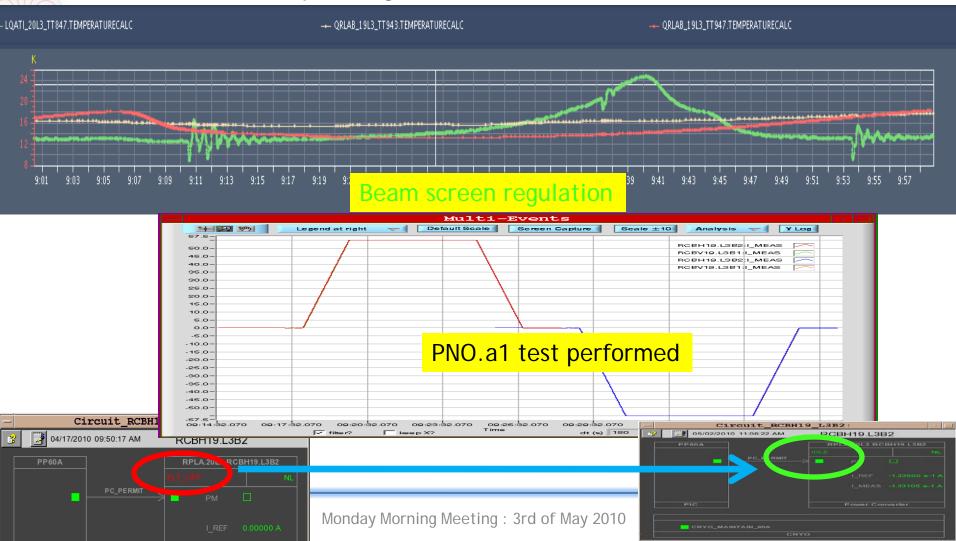
RCBH19.L3B2 & RCBV19.L3B1

Was locked due to problem on a cryo valves for the beam screen circuit cooling. Valve was changed during technical stop by CRG and test performed to validate it (29/04 profiting from an access in 45)

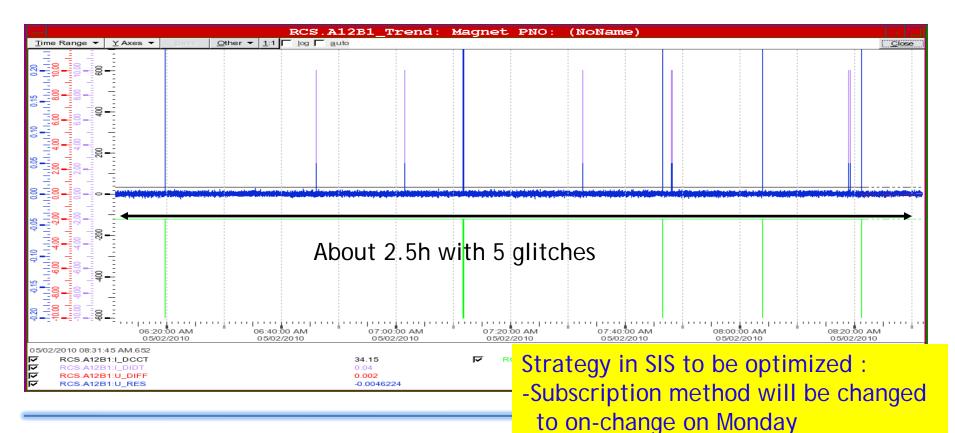
QPS_OK check is now active for all 600 A circuits with a check every 10 minutes. If verified during short glitch, injection is not possible for 10 minutes or interlock has to be masked

- Circuits masked after verification that QPS was OK:
 - + RQS.R5B1, RCS.A12B1, RCO.A81B1
 - + QPS board reset does not solve the issue

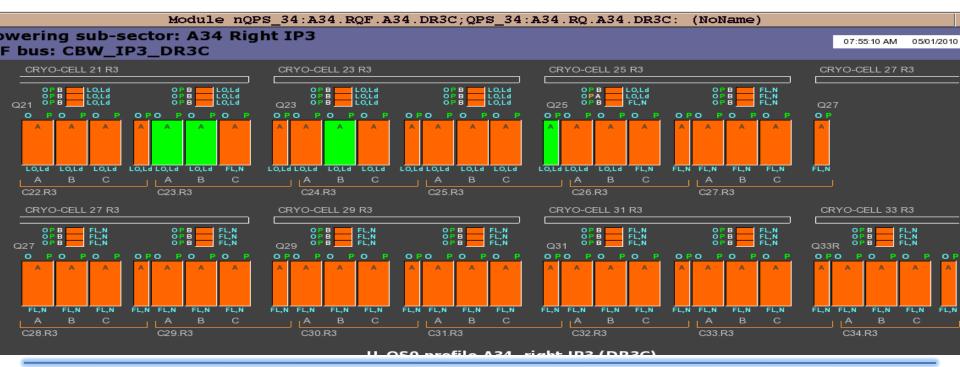
RB.A34, RQF/D.A34: Loss of com + QPS_OK

On 1st of May @ 7:03 loss of QPS_OK for mains in 34 for ¼ of the sector + Joint BE-CO/MPE/MP3 effort allowed localising the problem to a badly inserted/clamped wire inside the WorldFip connector of the nQPS crate B23R3, resulting in the loss of communication for the whole segment + In the meantime, as magnets were at injection current, interlock was masked but ramping-up and pre-cycle were forbidden
