# Tevatron Commissioning and Operating Experience

*Mike Martens*

*Tevatron Dept, Fermilab*

*January 24, 2005*

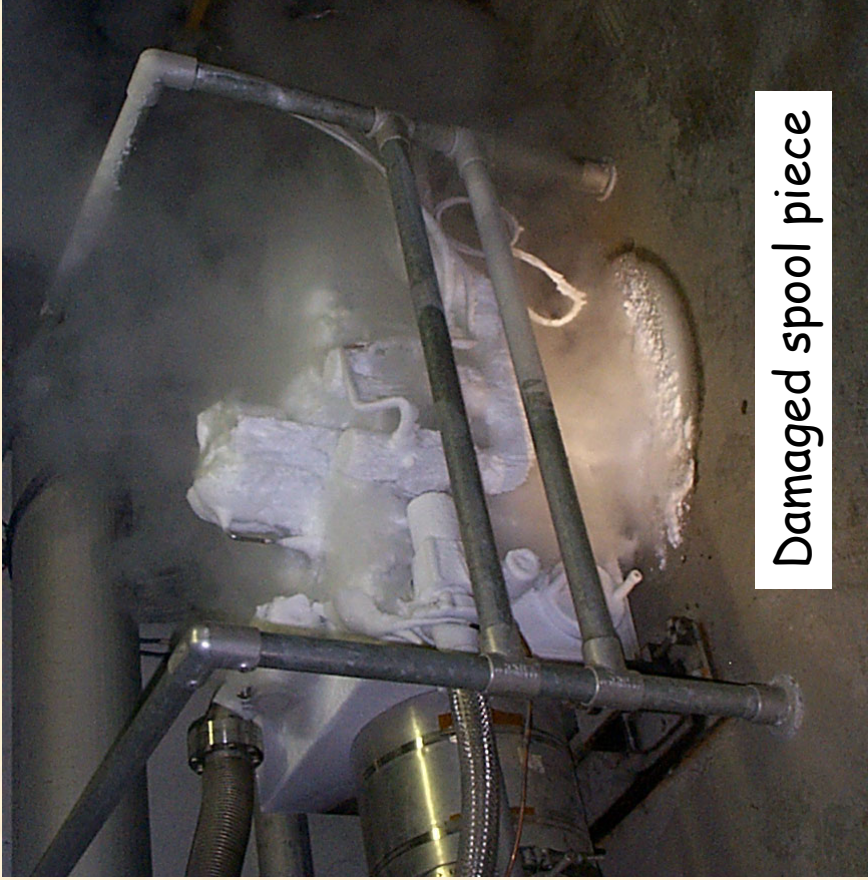
Damaged spool piece

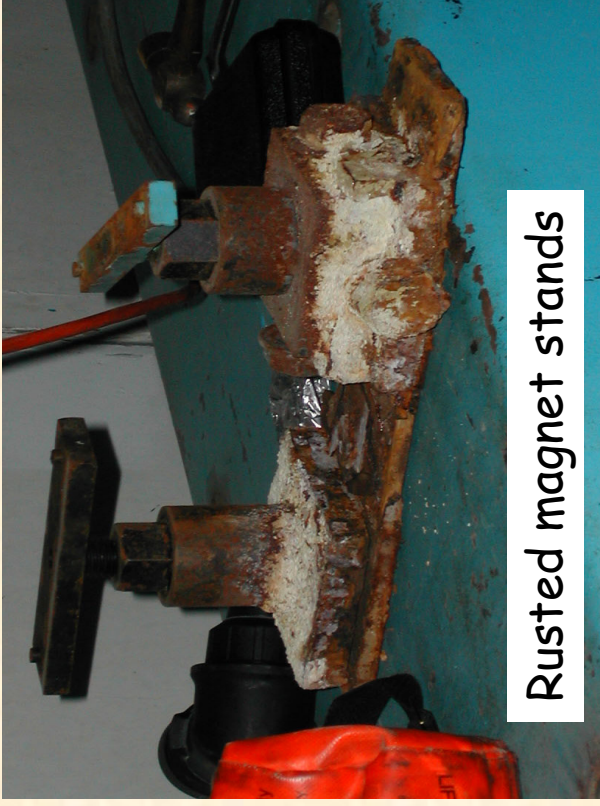
Rusted magnet stands

and signs of aging ...

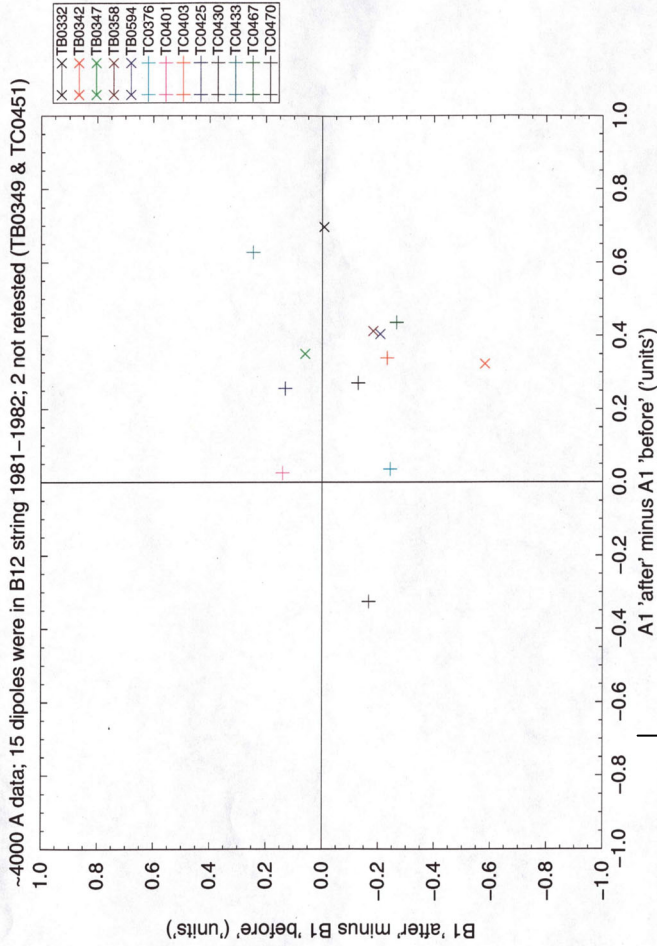
**CD Probe Position Data: Change in A1, B1 'before' to 'after' B12 Test**

**B12 test: early evidence of a1 problem**

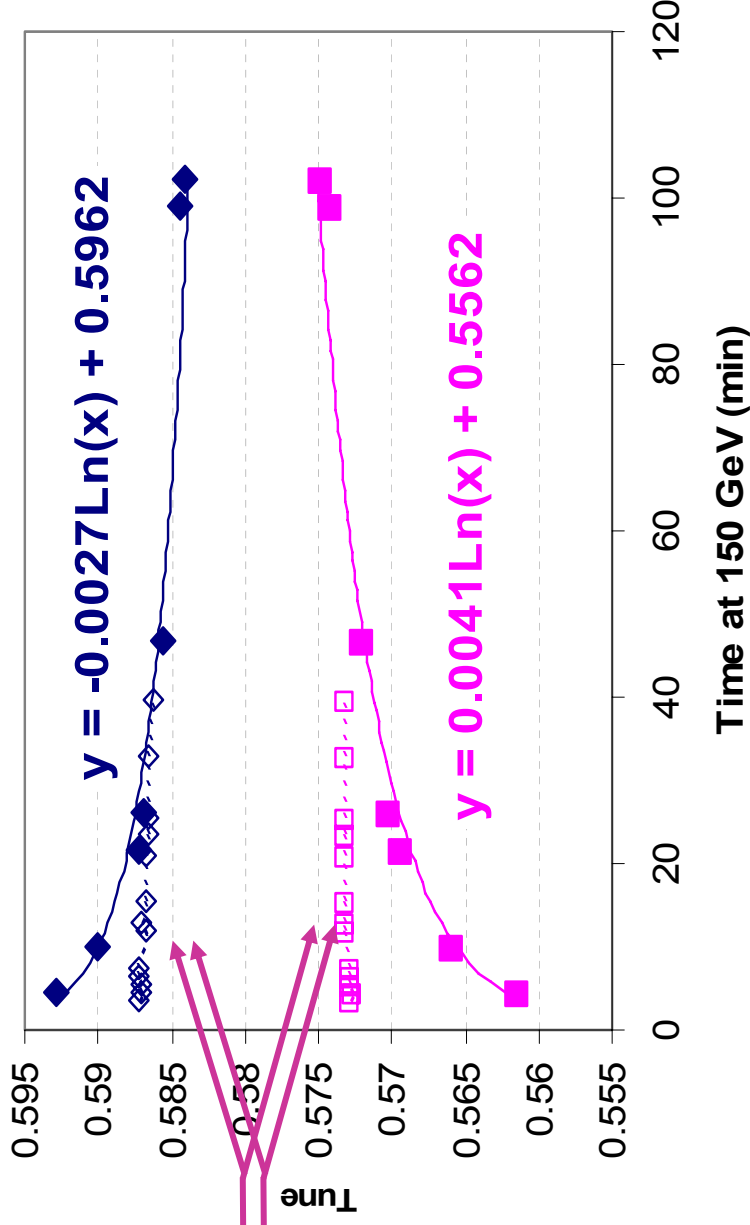
After correction algorithm was implemented

Tev needs  $\Delta v(t) < 0.002$

Why does the tune drift?  
Is it related to  $b_2$  drift?  
Noticed only in Run II?

Coupling drifts also.  
 $\Delta v_{\min} = 0.02$  tune units

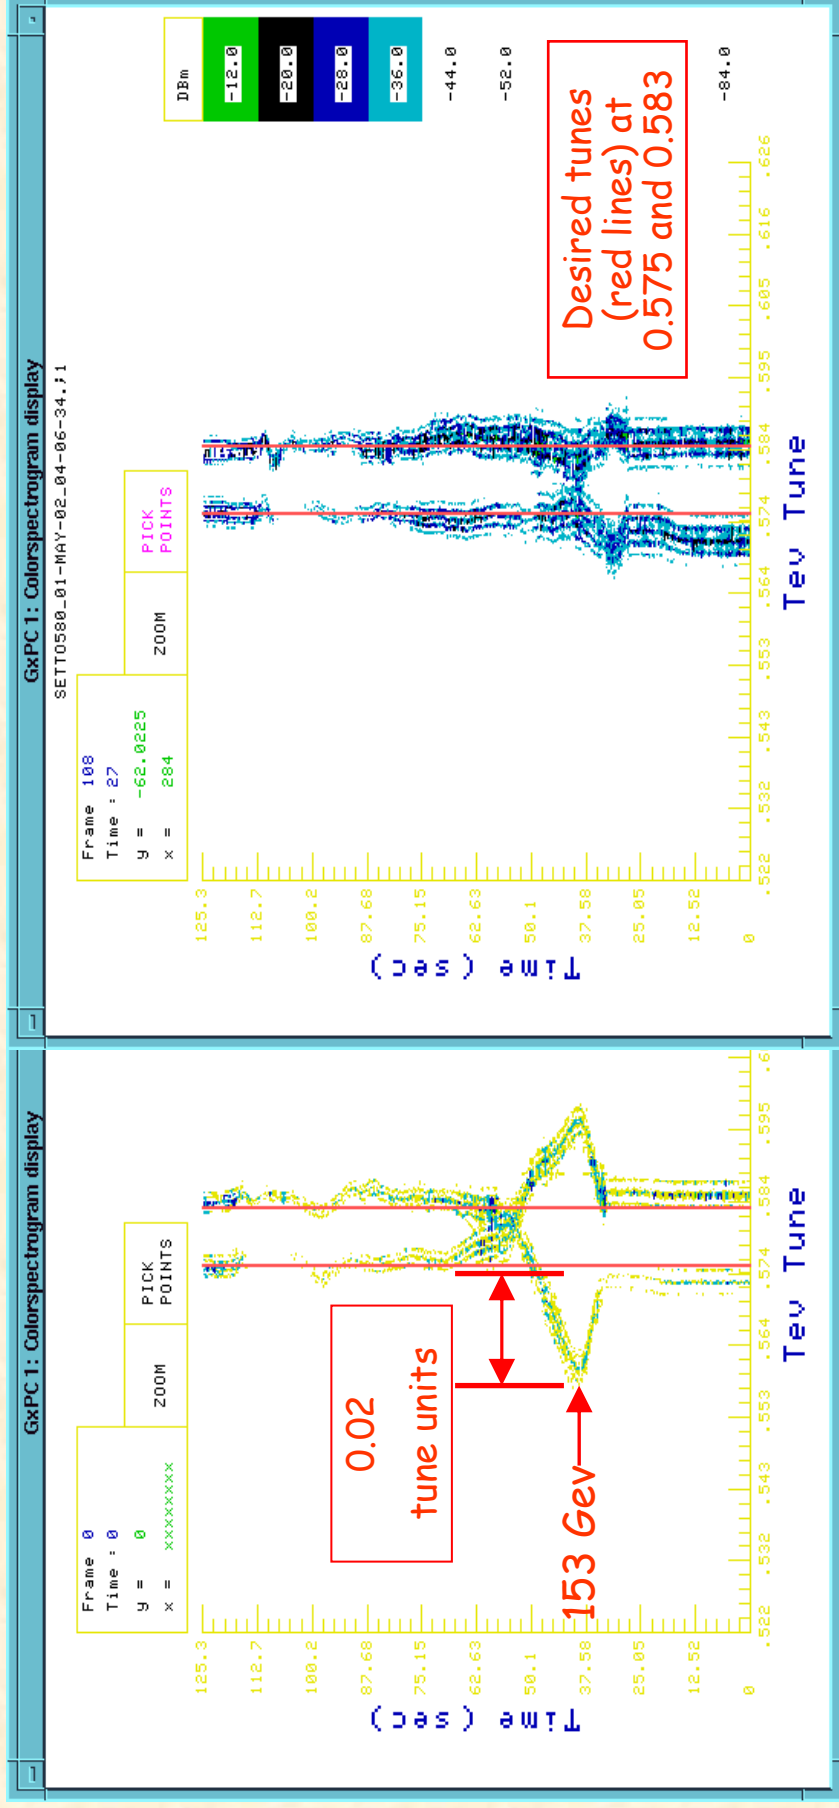
- Near start of ramp (150 → 153 Gev): large tune/coupling excursions
- Tune/coupling changes of (0.02 tune units, 0.02 minimum tune split)
- Variations fixed with additional breakpoint at 153 Gev and tune/coupling snapback correction at start of ramp.

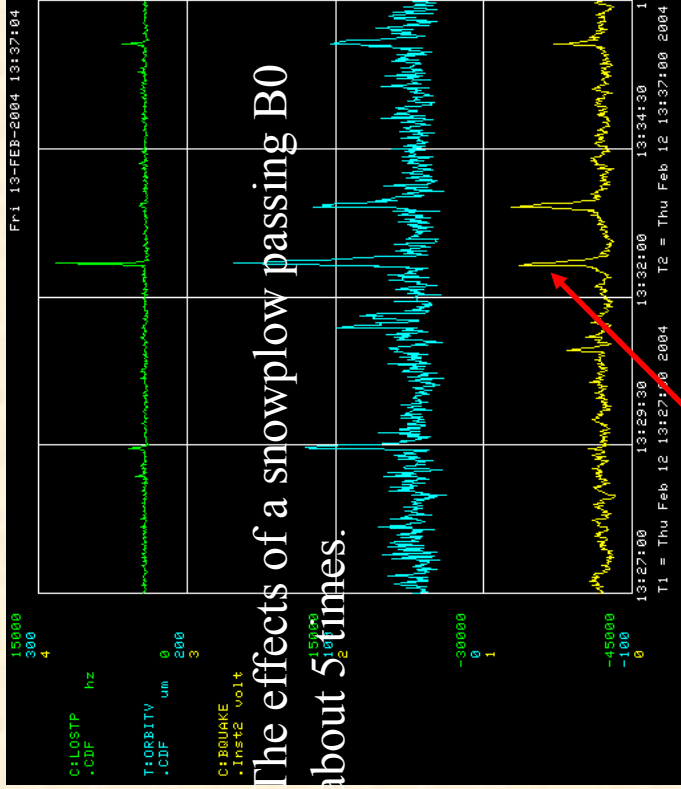
The effects of a snowplow passing B0 about 5 times.

Explains the source of spikes on the BLMs

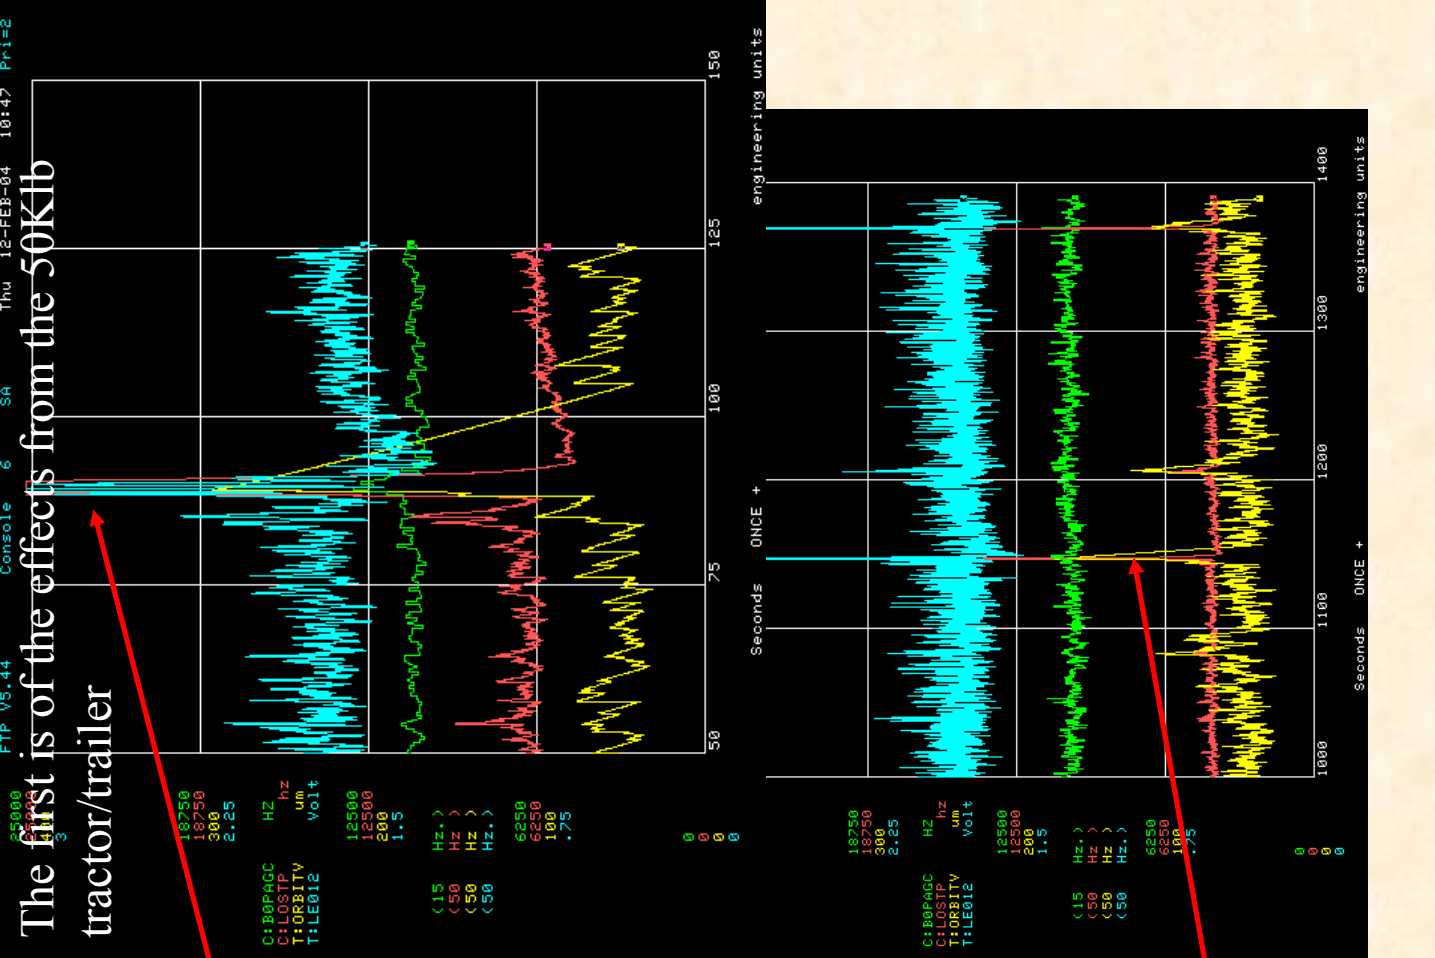
The first is of the effects from the 50Klb tractor/trailer

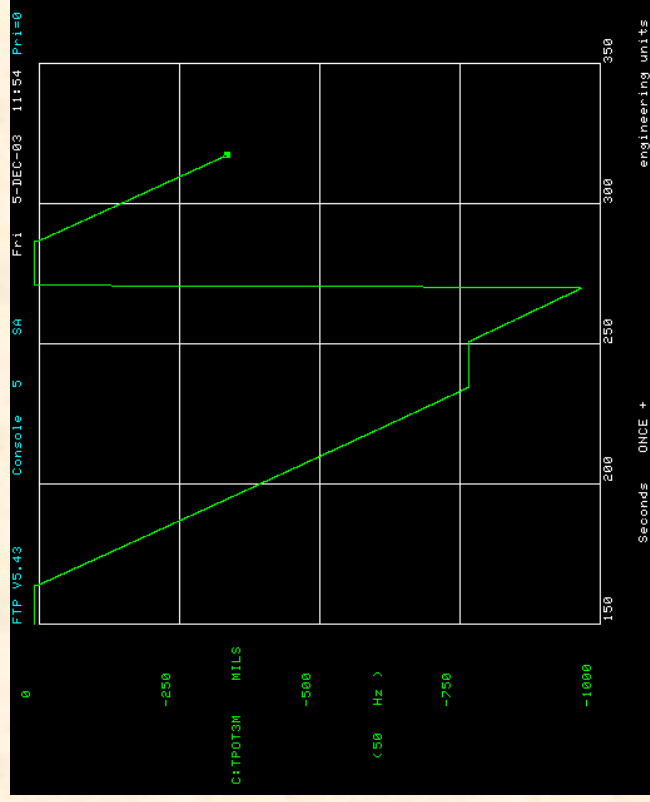
Pots have been found in additional failure test to move at 1200mils/sec.

Reproduced after quench  
On Dec 5, 2003

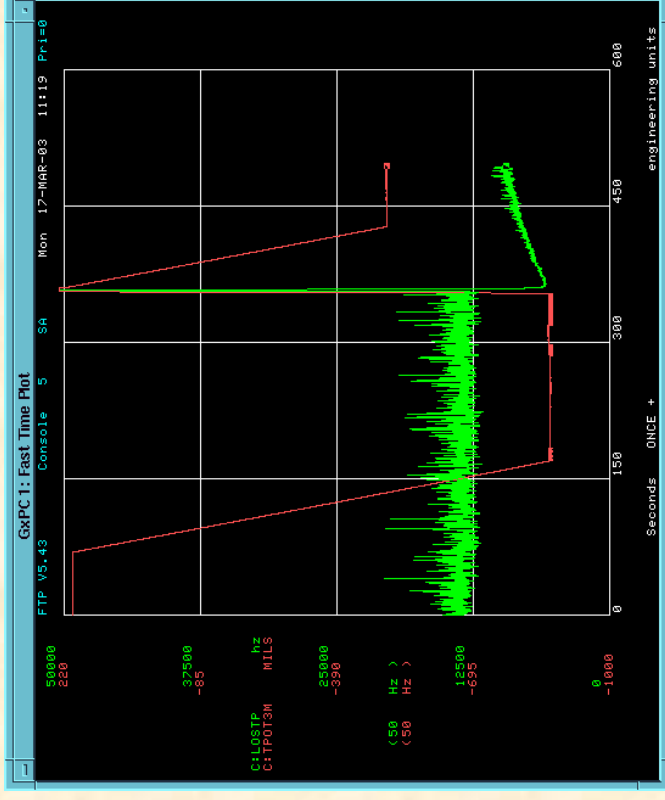
Similar incident on  
~ 3/17/03

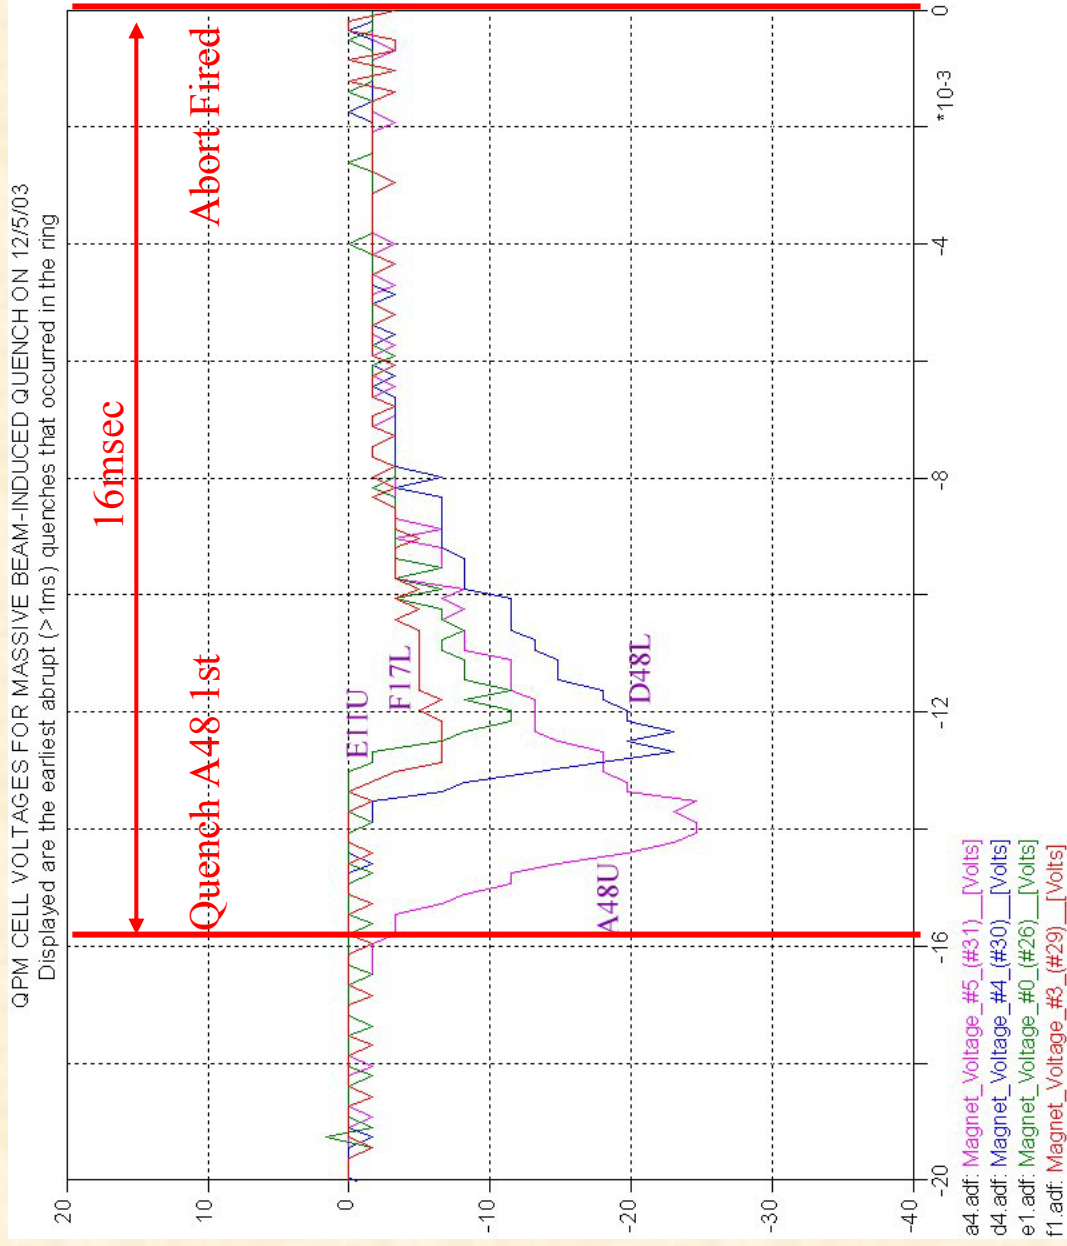
# QPM Over Sample Buffer

A48U 16msec

D48L 13.5msec

F17L 13msec

E11U 12.5 msec

Before abort

Quenched 5 dipoles at A48; DI/Dt = .5A/msec

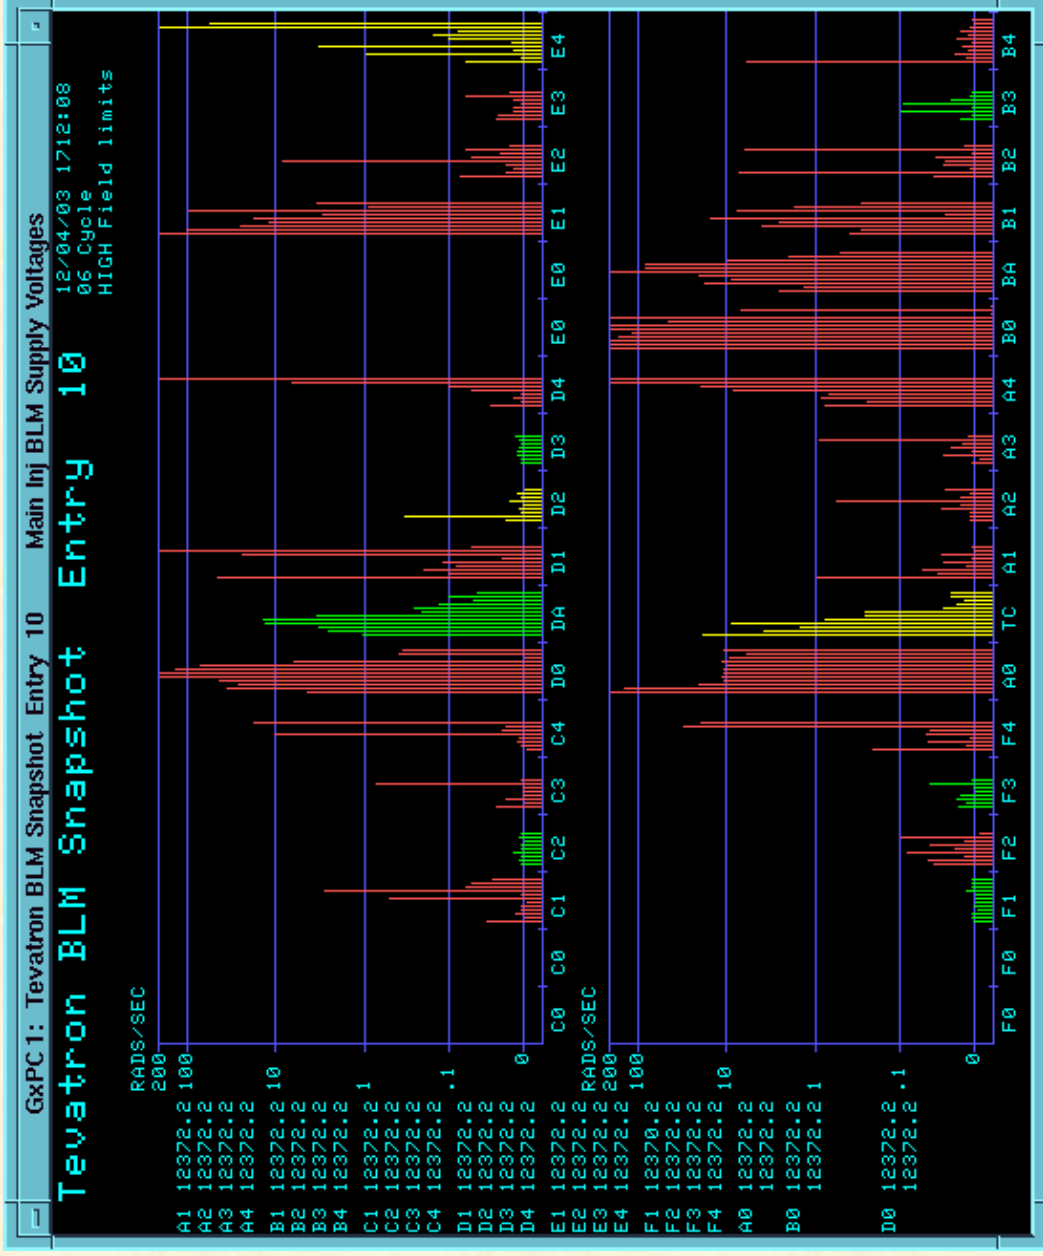
# Tevatron Ring Wide Loss Plot

- 
- 1) The current Quench Protection System would NOT be able to catch this type of event because it processes data at 60Hz / 16.67 msec.
  - 2) It might have been possible to stop damage to collimators with different loss monitor protection system other than SVX. This needs discussion and possible loss monitor hardware system upgrade.
  - 3) Even though 2 collimator devices were damaged, these devices defined the limiting aperture and are easy to change and provided protection to other components.
