Saturday 19 June

After beta beating measurements checked that collapsing of separation bumps and crossing angle knobs work correctly with low intensity beam

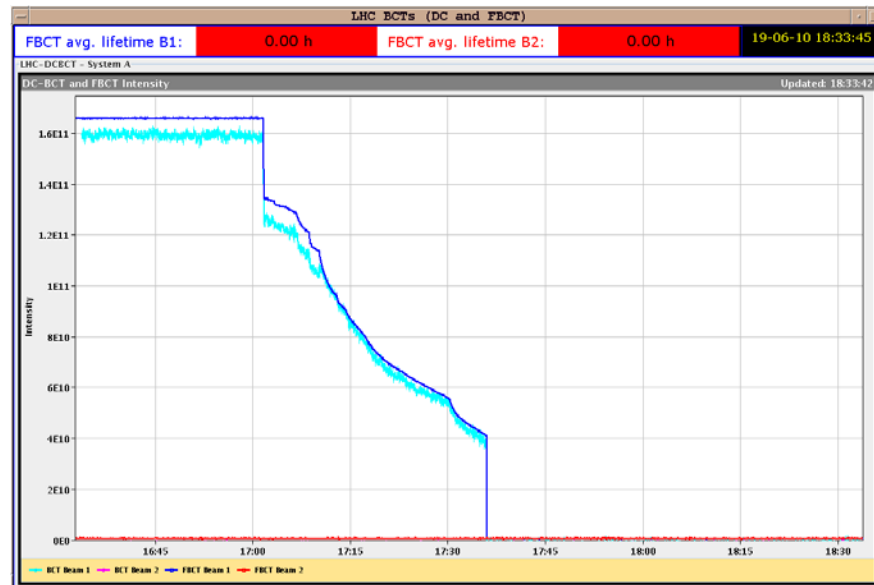
Continue with Beam 1 and test scraping to be used for qualification tests

Moved Q_v towards 3rd order resonance slowly in small steps

Started also to move Q_h

Lost beam 1 due to IP6 excursion interlock (sensitivity settings not changed when intensity was decreased). Could not mask yet as SBF was still false.
