- Main aim: Preparation for high bunch intensity operation with  $\beta^*=3.5$  m and crossing angle (-100  $\mu$ rad in IR1 and +100  $\mu$ rad in IR5)
- Commission systems required for guaranteeing beam stability as expected from design with single nominal bunch and more than one bunch:
  - Transverse feedback
  - Controlled longitudinal emittance blow-up
  - Octupoles at 3.5 TeV
- Setting-up for high intensity operation and consolidation of the beam parameters control during ramp and squeeze:
  - Squeeze with separated beam, orbit and tune feedback
  - Chromaticity correction and minimization
- Optimization and qualification of the machine protection with higher intensity:
  - Collimation setting-up at 3.5 TeV
  - Dump protection setting-up

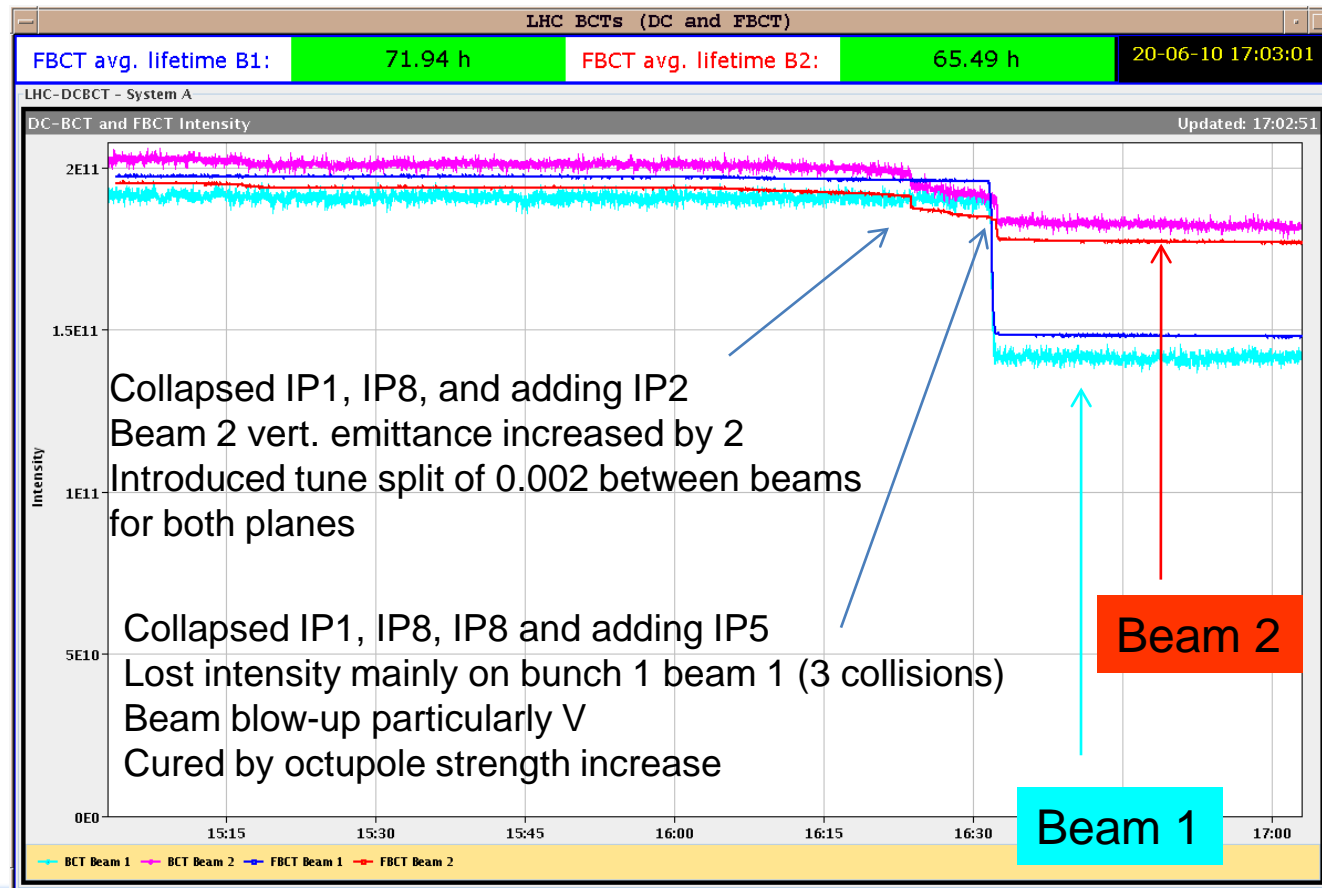
- Robust squeeze to 3.5 m - Tune, orbit FB on
- One stop at 7 m to drive the collimators
- Collapse of the separation bumps
  - IP1: 1x1
  - IP8: 17851 x 8911
  - IP2: 1x 8911
  - IP5: 1x1
